WEEKLY PROJECT REPORT-008

AS ON 05 OCT 2011

Ekushey Bhaban-Superstructure-Progress

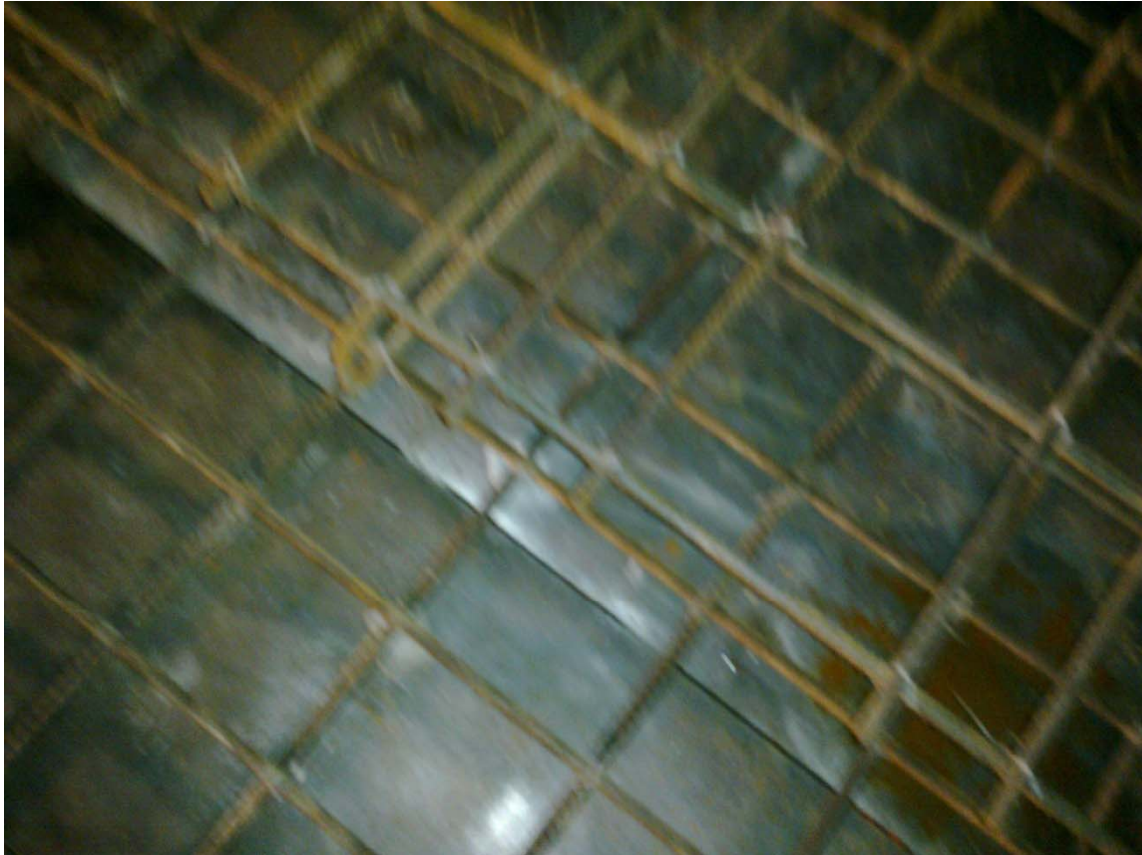
QUALITY-ALERT

GAP BETWEEN MS SHEET SHOULD BE ELIMINATED
Cause Honeycomb due to water leakage.

Gap between MS Sheet should be eliminated. This will cause honey comb due to water leakage. Photograph attached.

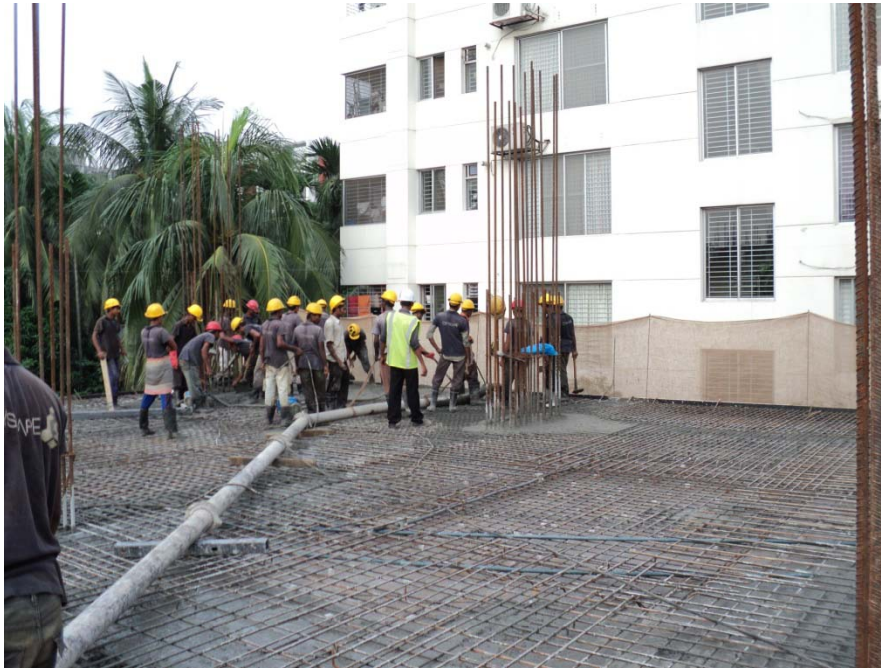
1ST FLOOR ROOF SLAB CONCRETING

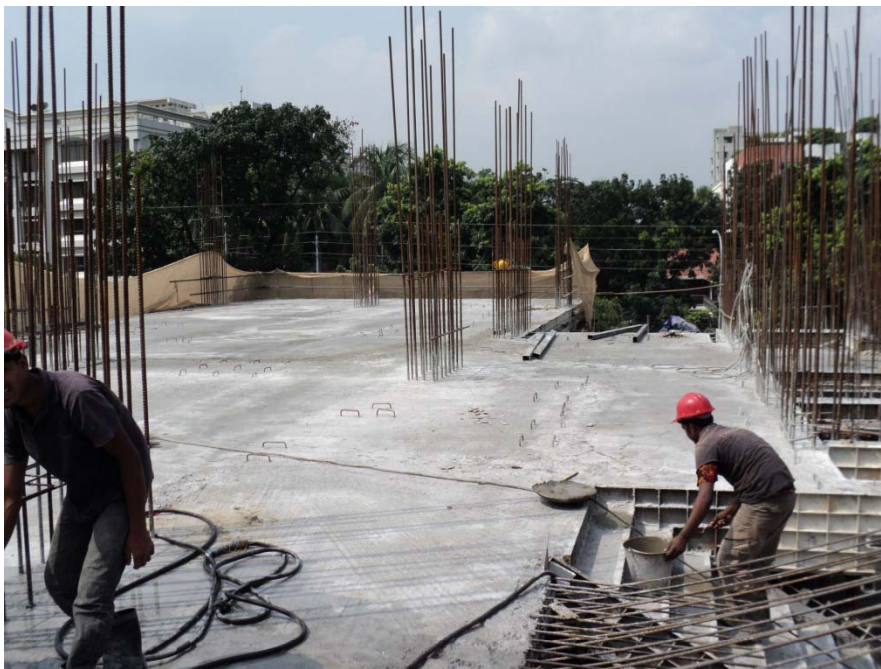
1ST FLOOR ROOF SLAB CONCRETING-FINISHING WORK

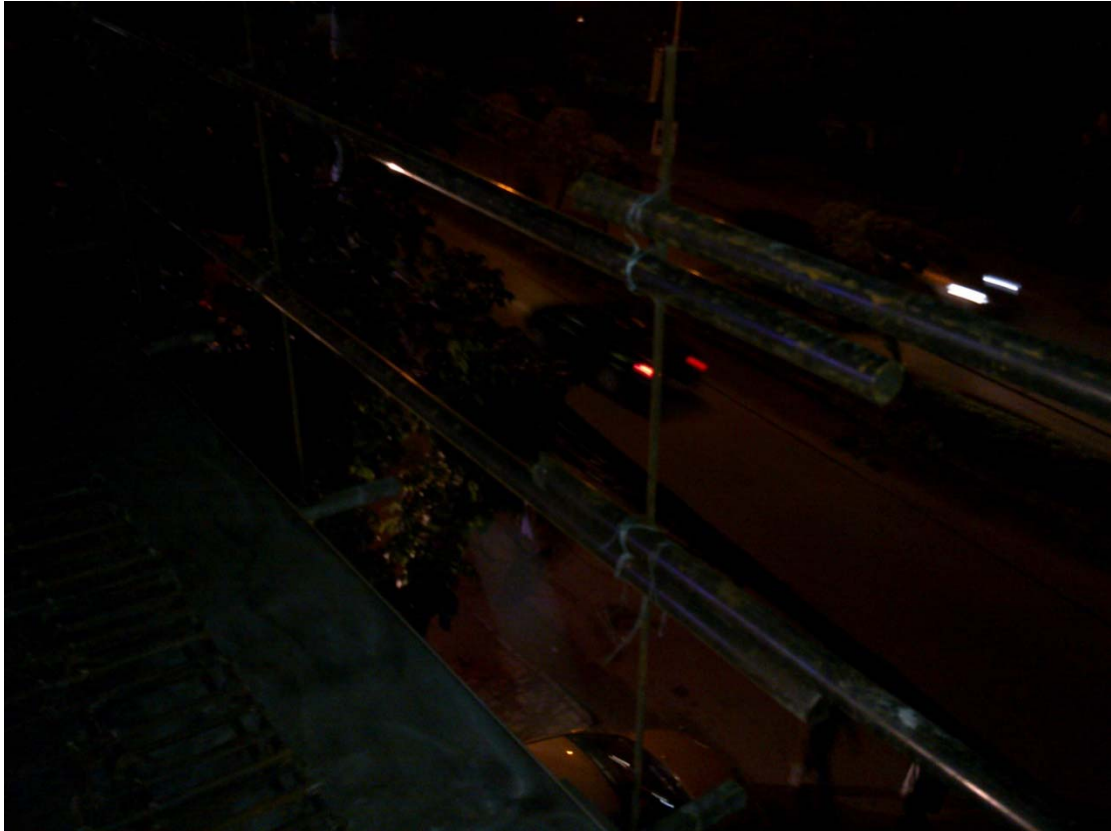
SAFETY – ROOF EDGE PROTECTION

POOR ROOF EDGE PROTECTION
(16mm dia vertical rod cannot bear 1.5" dia Horizontal GI Pipe)

| Proper Roof Edge protection should be needed. Photograph attached. |
