WEEKLY PROJECT REPORT

AS ON 03 AUG 2011

PROJECT SUMMARY AS ON: 03 AUG 2011

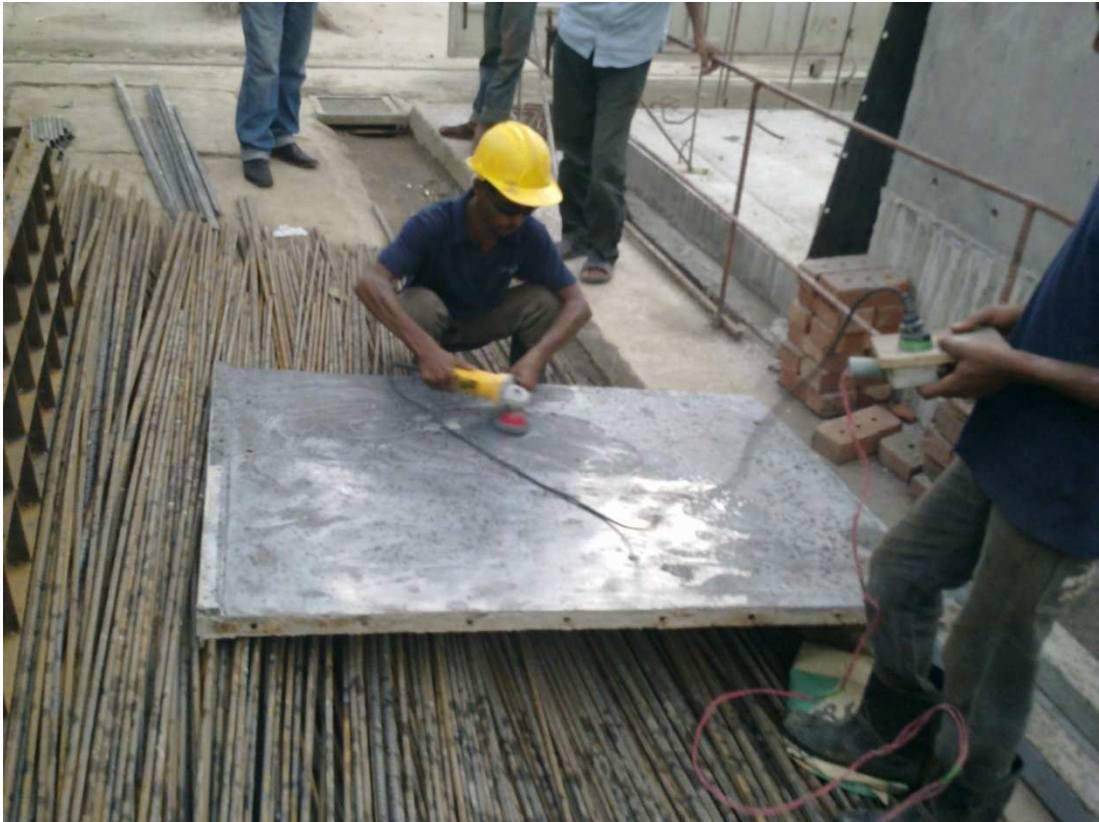
MS Shutter is cup brushing for better concrete surface

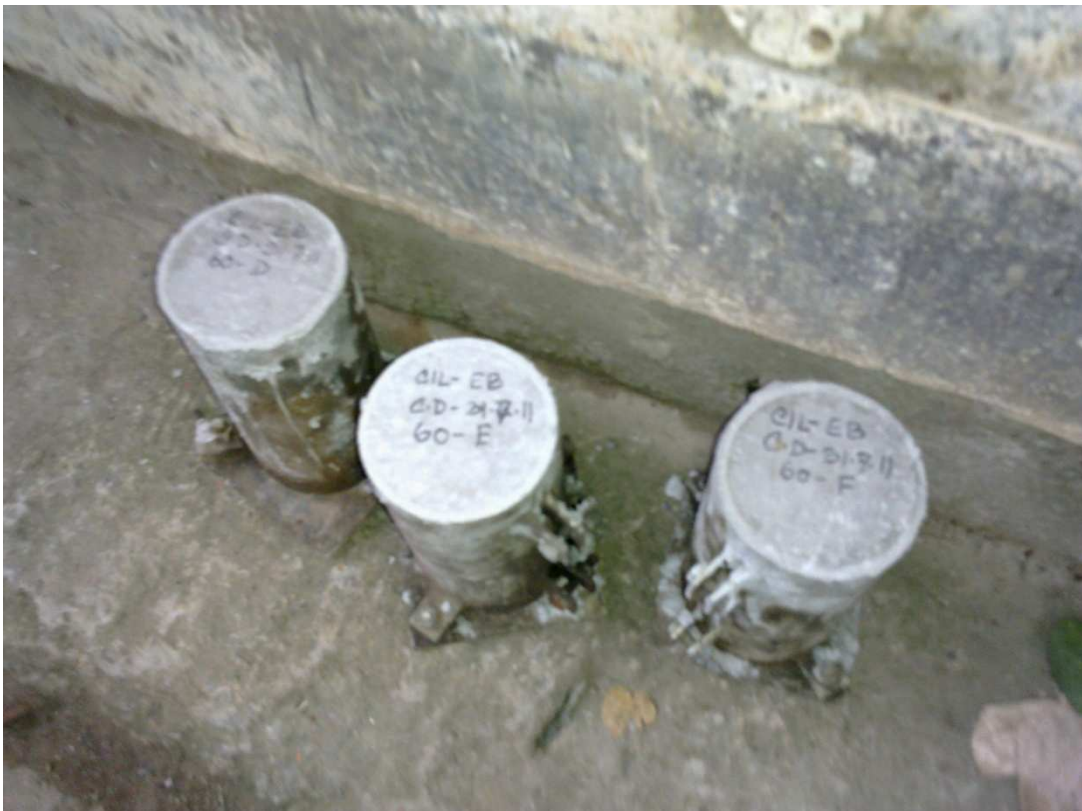
Concrete cylinder is taken for actual concrete strength test

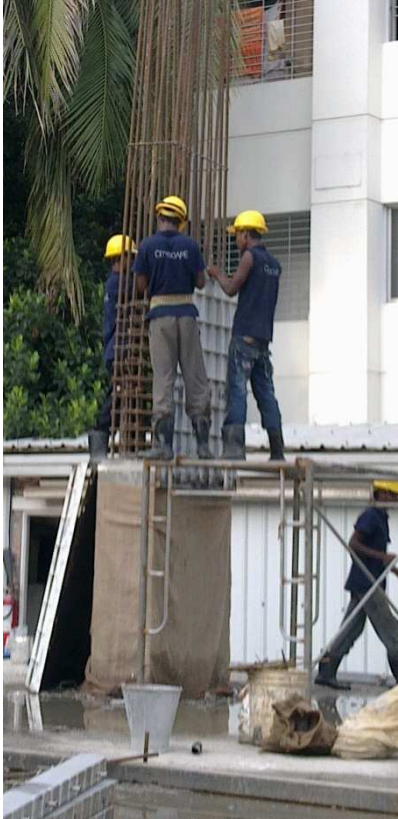
Improper Scaffolding, No Safety Belt
Danger of falling

1. Lack of safety measures (see attached picture)
 2. Safety supervisor should be immediately appointed to avoid any accident.

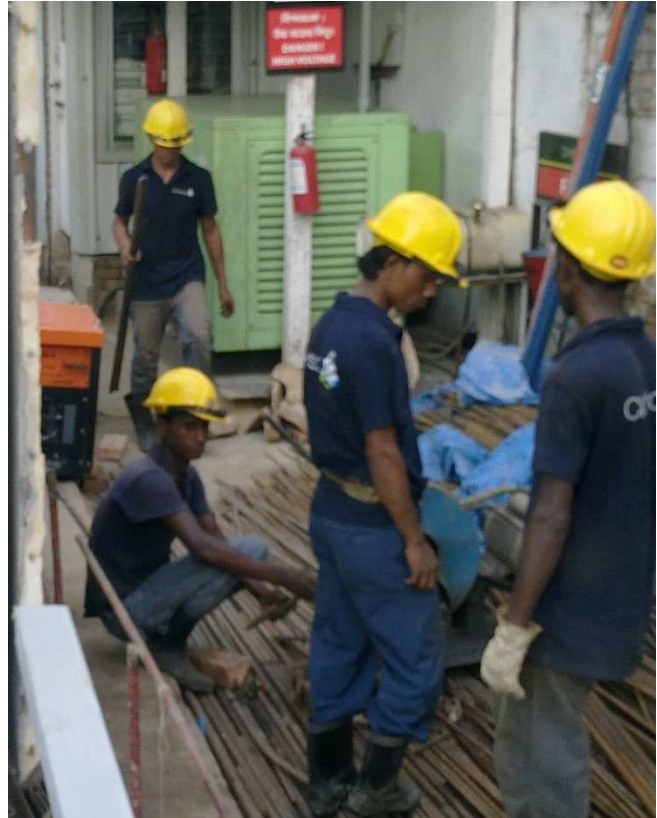
Rod cutting without Eye protection & Hand Gloves
Eye damage/ Finger Cutting

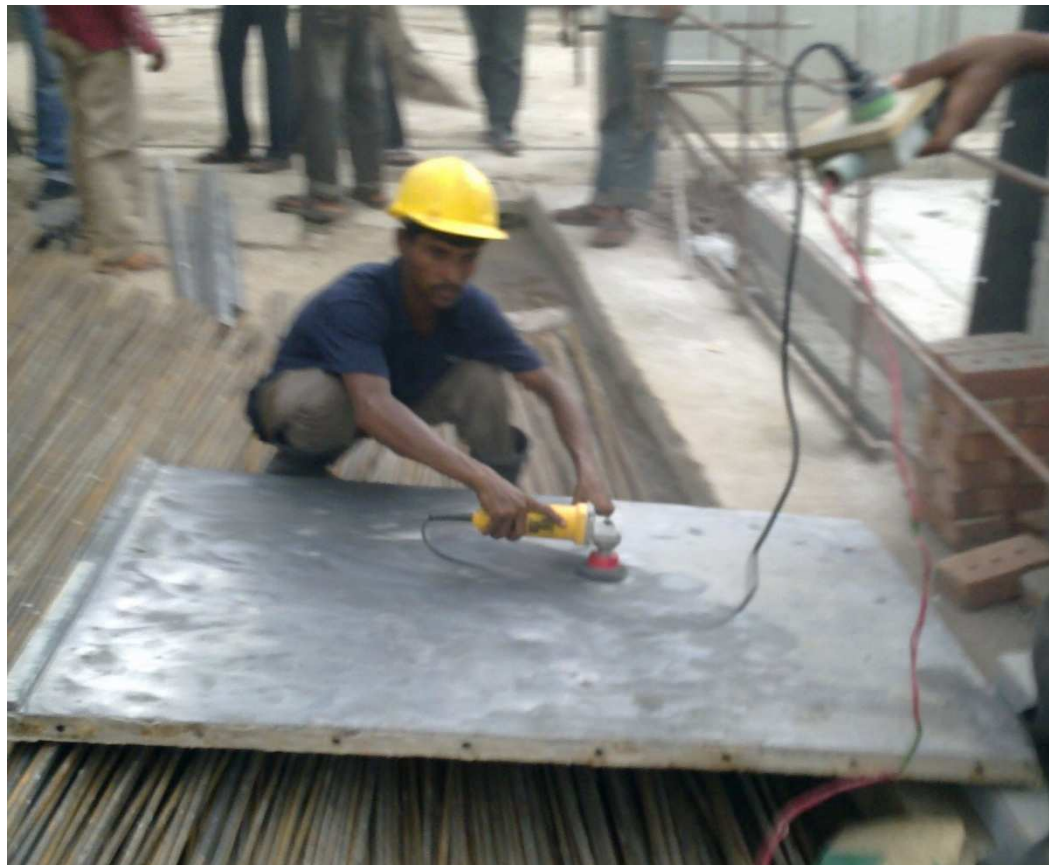
Shutter Brushing without Eye protection and hand-gloves
Eye damage
