WEEKLY PROJECT REPORT

AS ON 03 AUG 2011

PROJECT SUMMARY AS ON: 03 AUG 2011

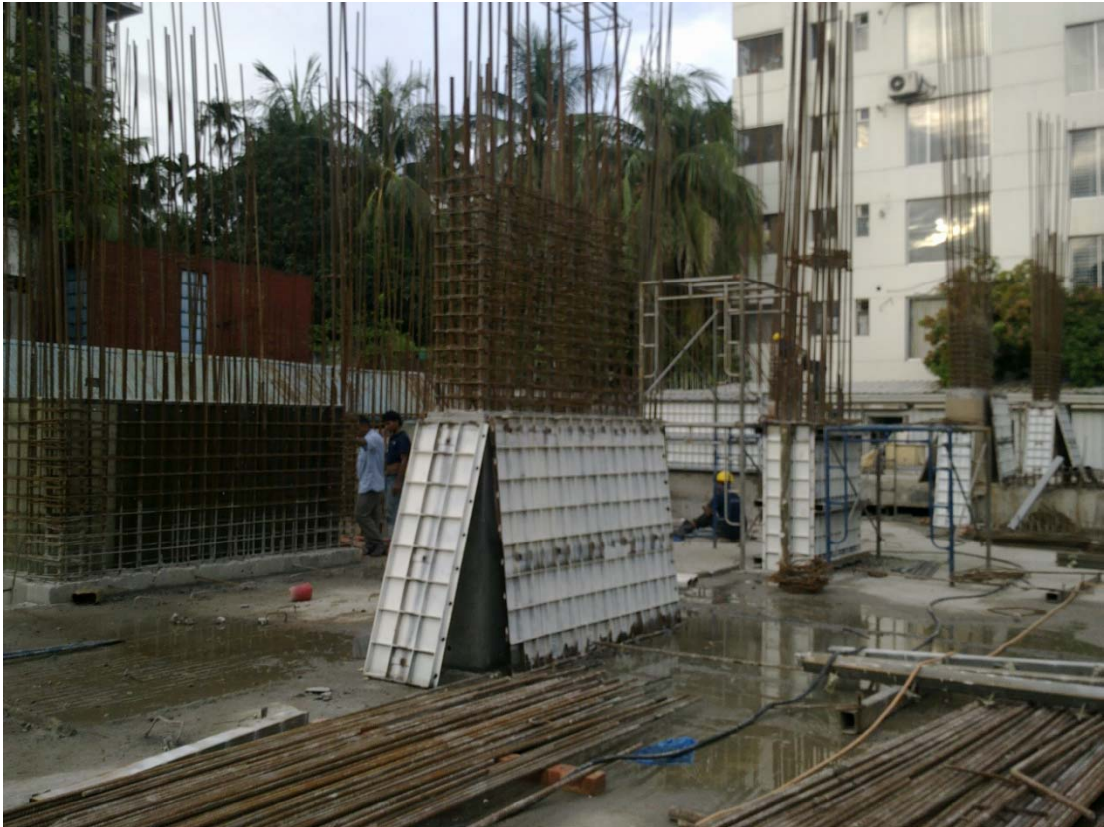
Photograph taken 03 Aug 2011 05:46 PM

- Concreting of 1st lift of Column is behind the schedule which can be overcome by concrete both lift by 05th August.
- Quality as per specification
- Lack of Safety measure. A safety Officer should be appointed
- Contractor for masonry work should be selected to do masonry works in basements.
