WEEKLY PROJECT REPORT-007

AS ON 28 SEP 2011

Ekushey Bhaban-Superstructure-Progress

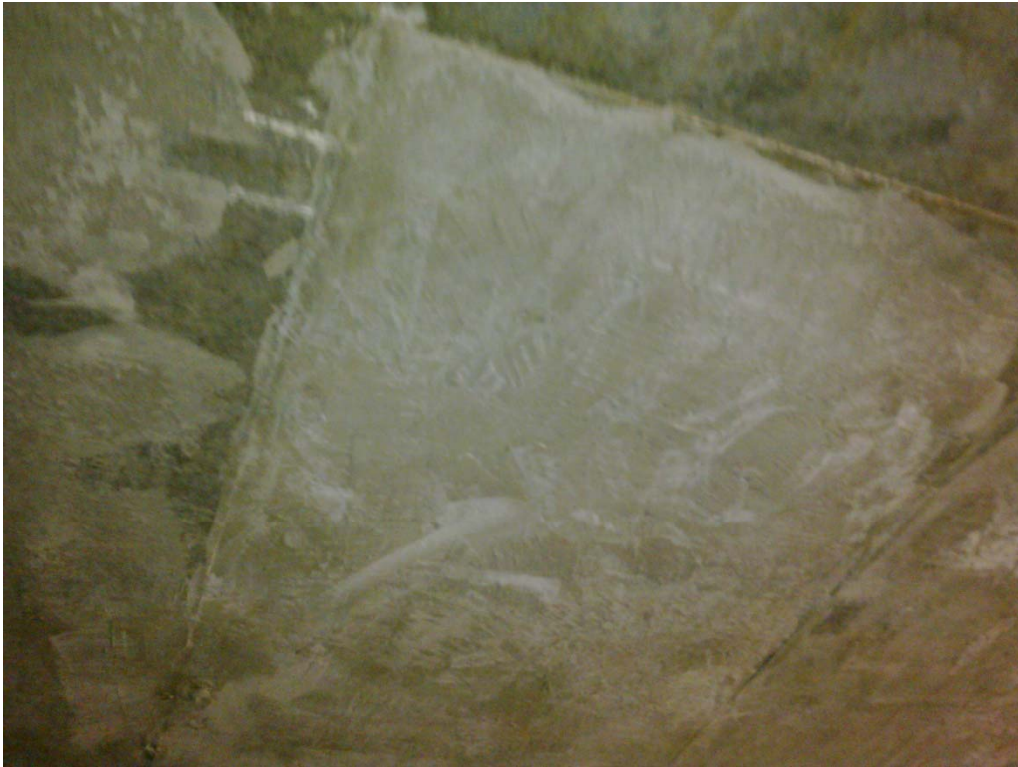
Picture taken: 28 Sep 2011 :07:49 PM

Patching work (photograph attached) is observed in ground floor ceiling. This is due to poor workmanship (not properly grinding/ oiling/ not vibrating/ concrete setting). Contractor should be penalised for this, so that next time he will be conscious about that.

POOR QUALITY

POOR WORKMANSHIP-GROUND FLOOR ROOF SLAB

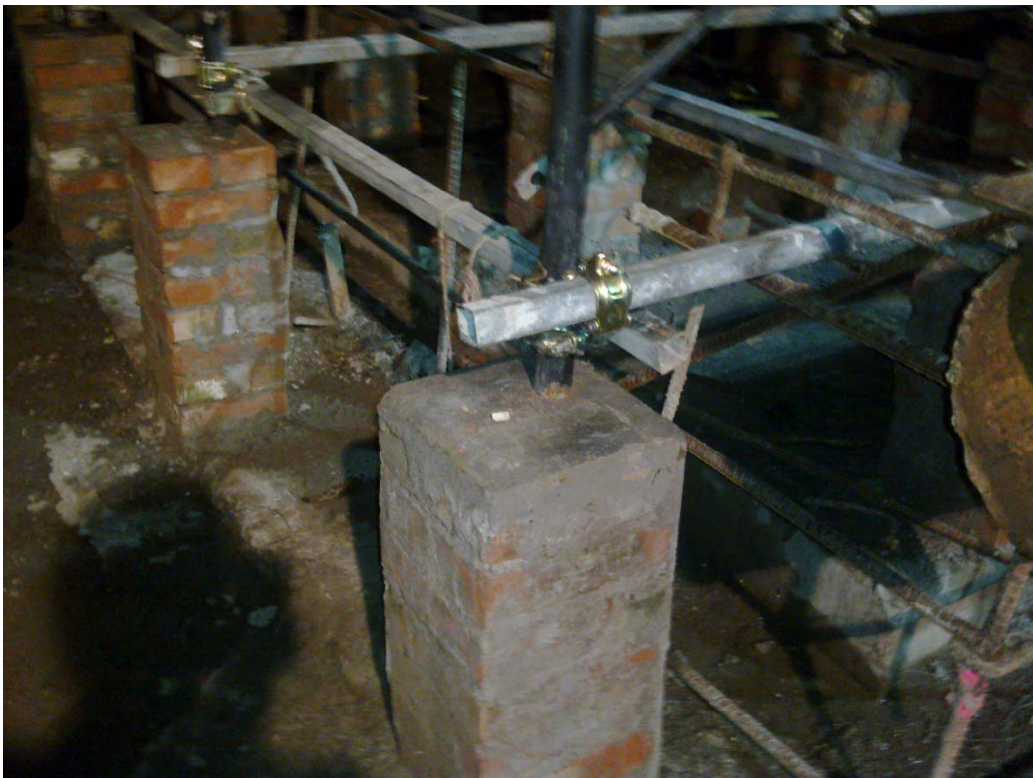
Picture taken: 28 Sep 2011 :07:32 PM

IMPROPER SCAFFOLDING-BASE PLATE NEEDED

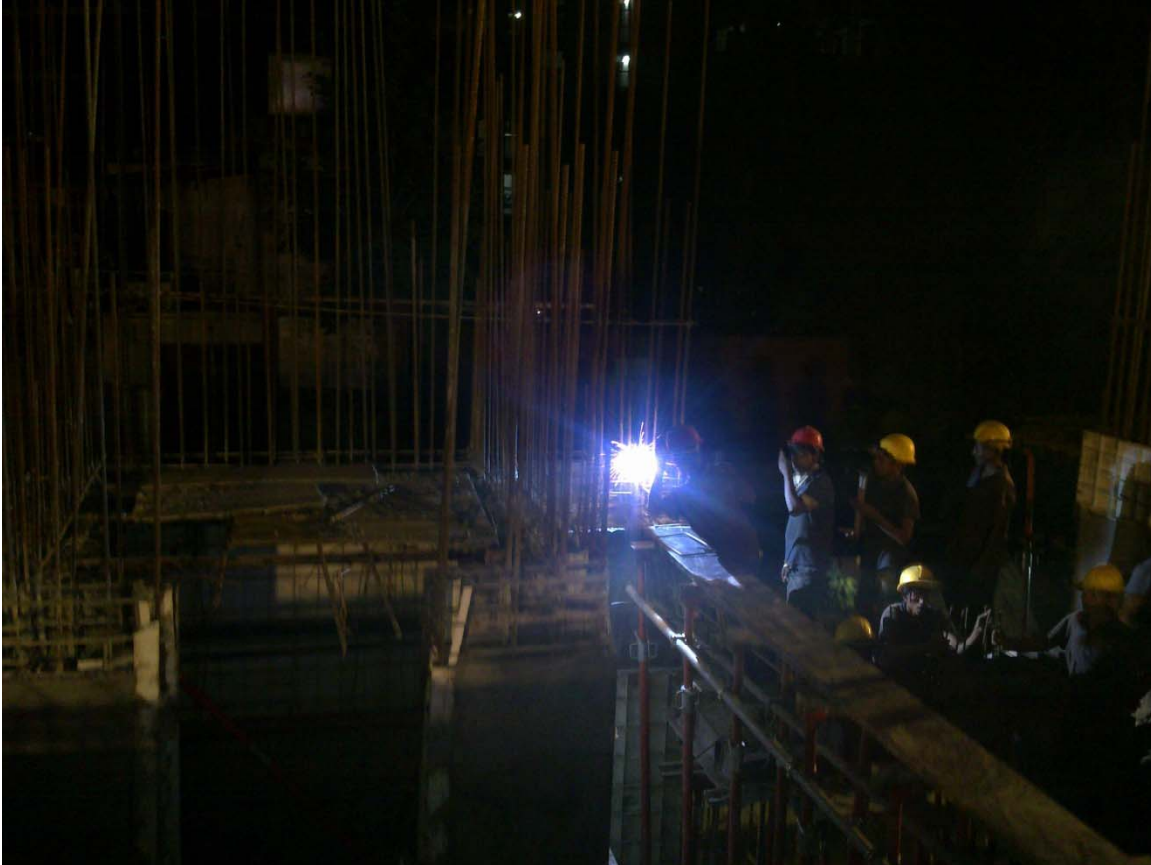
Photographs taken: 11 Sep 2011 07:43 PM

SAFETY PUNISHMENT

WELDING WITHOUT EYE PROTECTION(SAFETY GOGGLES)
– Cause Eye Damage

Contractor	Name	Trade	Induction ID
Sohel Enterprise	Ibrahim	Welder

Proper safety measure should be taken (Photo attached)
_____ Consultant
_____ Chief Engineer

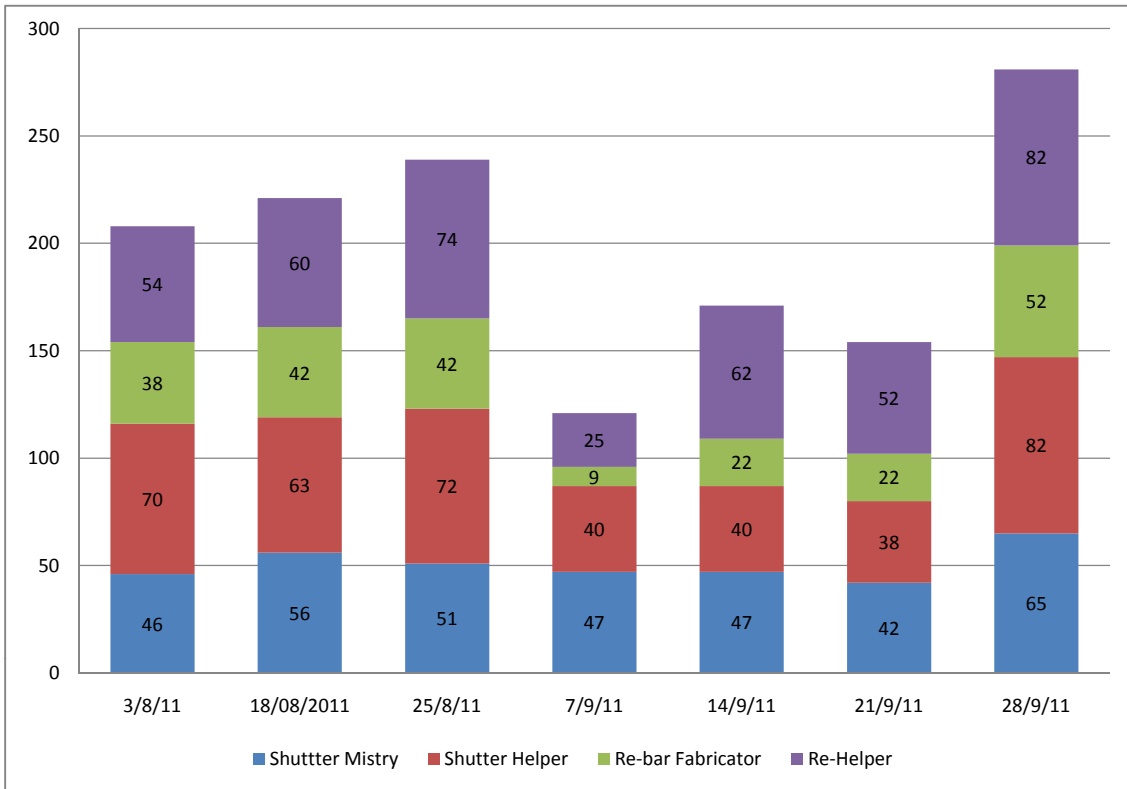
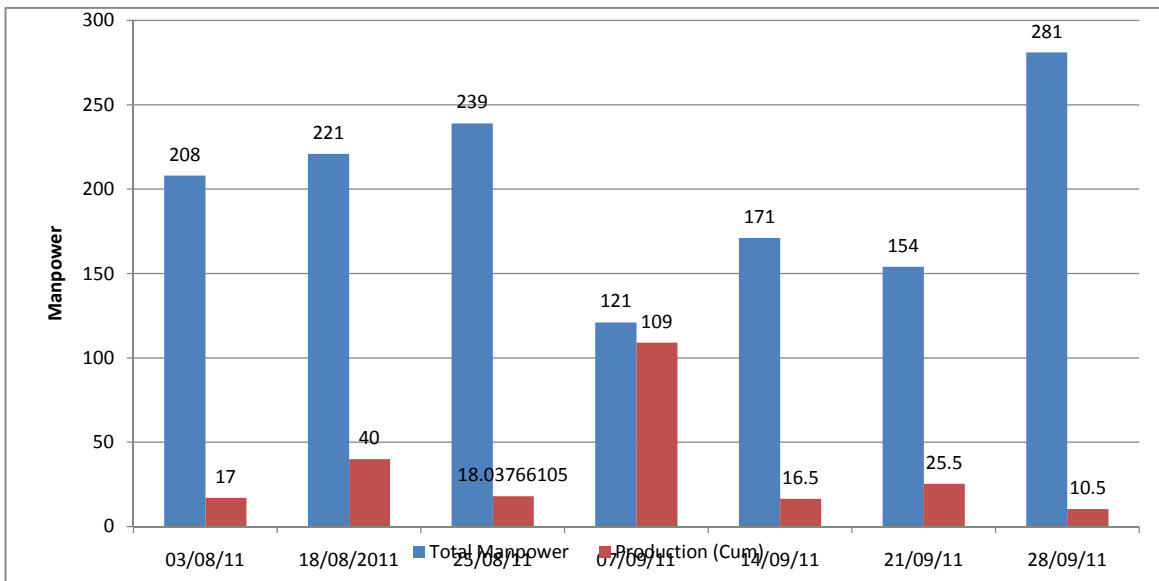
MANPOWER HISTOGRAM

Manpower is less than last week. See detail in attached Histogram
